Marketing Research Report No. 485

TRANSPORTATION OF HANGING BEEF BY REFRIGERATED RAIL CARS AND 'PIGGYBACK' TRAILERS

U.S. DEPARTMENT OF AGRICULTURE
Agricultural Marketing Service

By H. D. Johnson, R. F. Guilfoy, and R. W. Penney,
Transportation and Facilities Research Division,
Agricultural Marketing Service

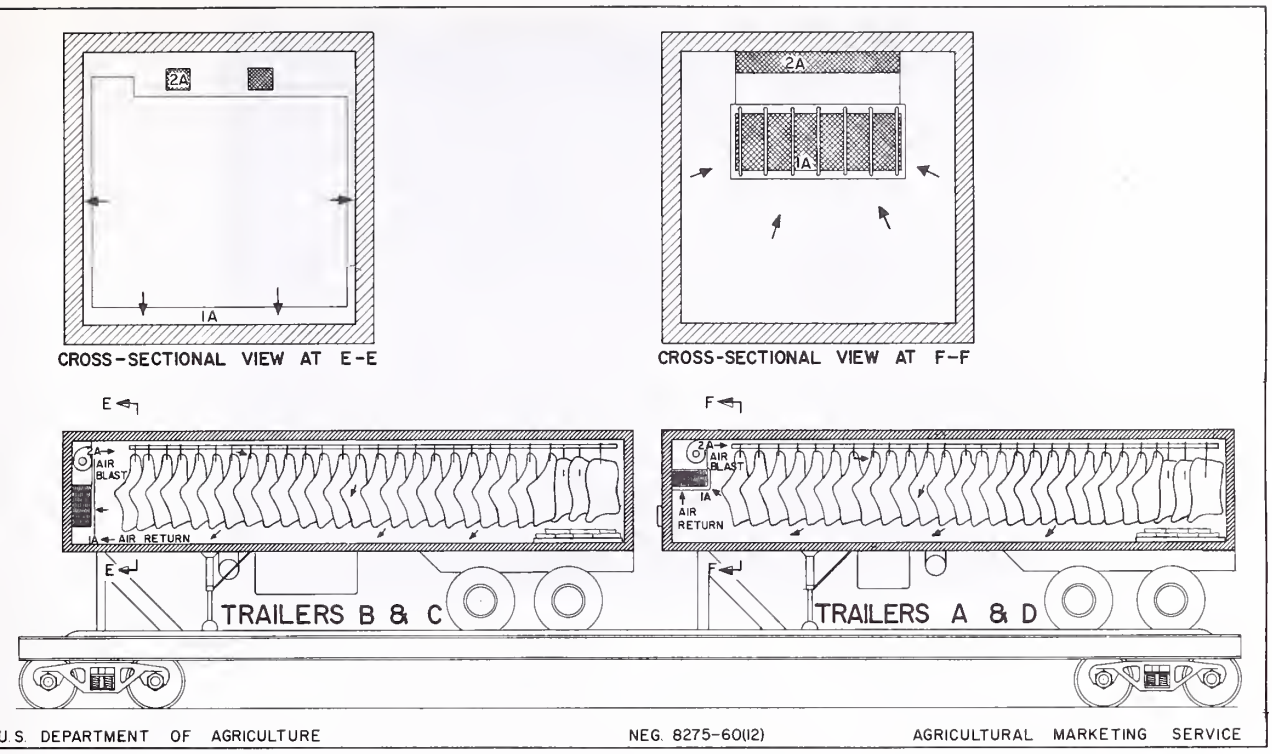
Figure 3.--General construction of trailers A, B, C, and D, showing loading pattern, location of refrigeration unit, and air blast directly into load.

Beef temperatures are kept more uniform by distributing the air around the load than by blasting the air into the load. Therefore, a duct down each side of the trailer at the ceiling would probably improve trailer performance. The semi-envelope design in car B provided the best air distribution for the two rail cars tested.

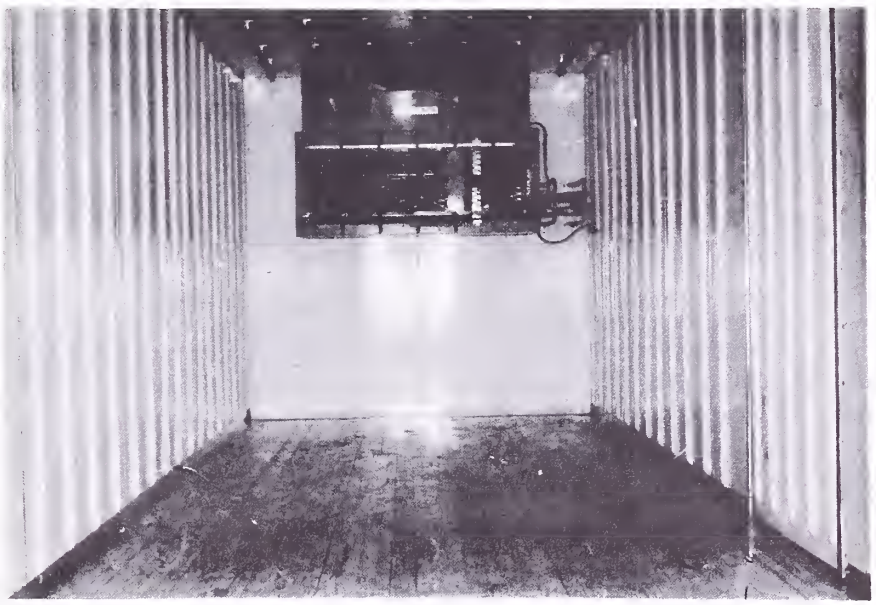
BN-13577x

Figure 4.--Interior of trailers A and D.

Trailer A.--The thermostat was supposedly set at 32° F. However, it was actually set at 30°. This error was probably due to the location of the thermostat, high on the nose of the trailer, which did not allow easy access for setting the dial. In addition, the dial was about one-half inch away from the face of the instrument, which allowed a variation in setting, depending upon the angle of vision of the operator. On the second day, July 19, the thermostat was reset to 27°. When delivered, the beef was about 34°, or 7° higher than the thermostat setting.

The thermostat dial on all trailers should be at eye level height for easy access and accurate setting.

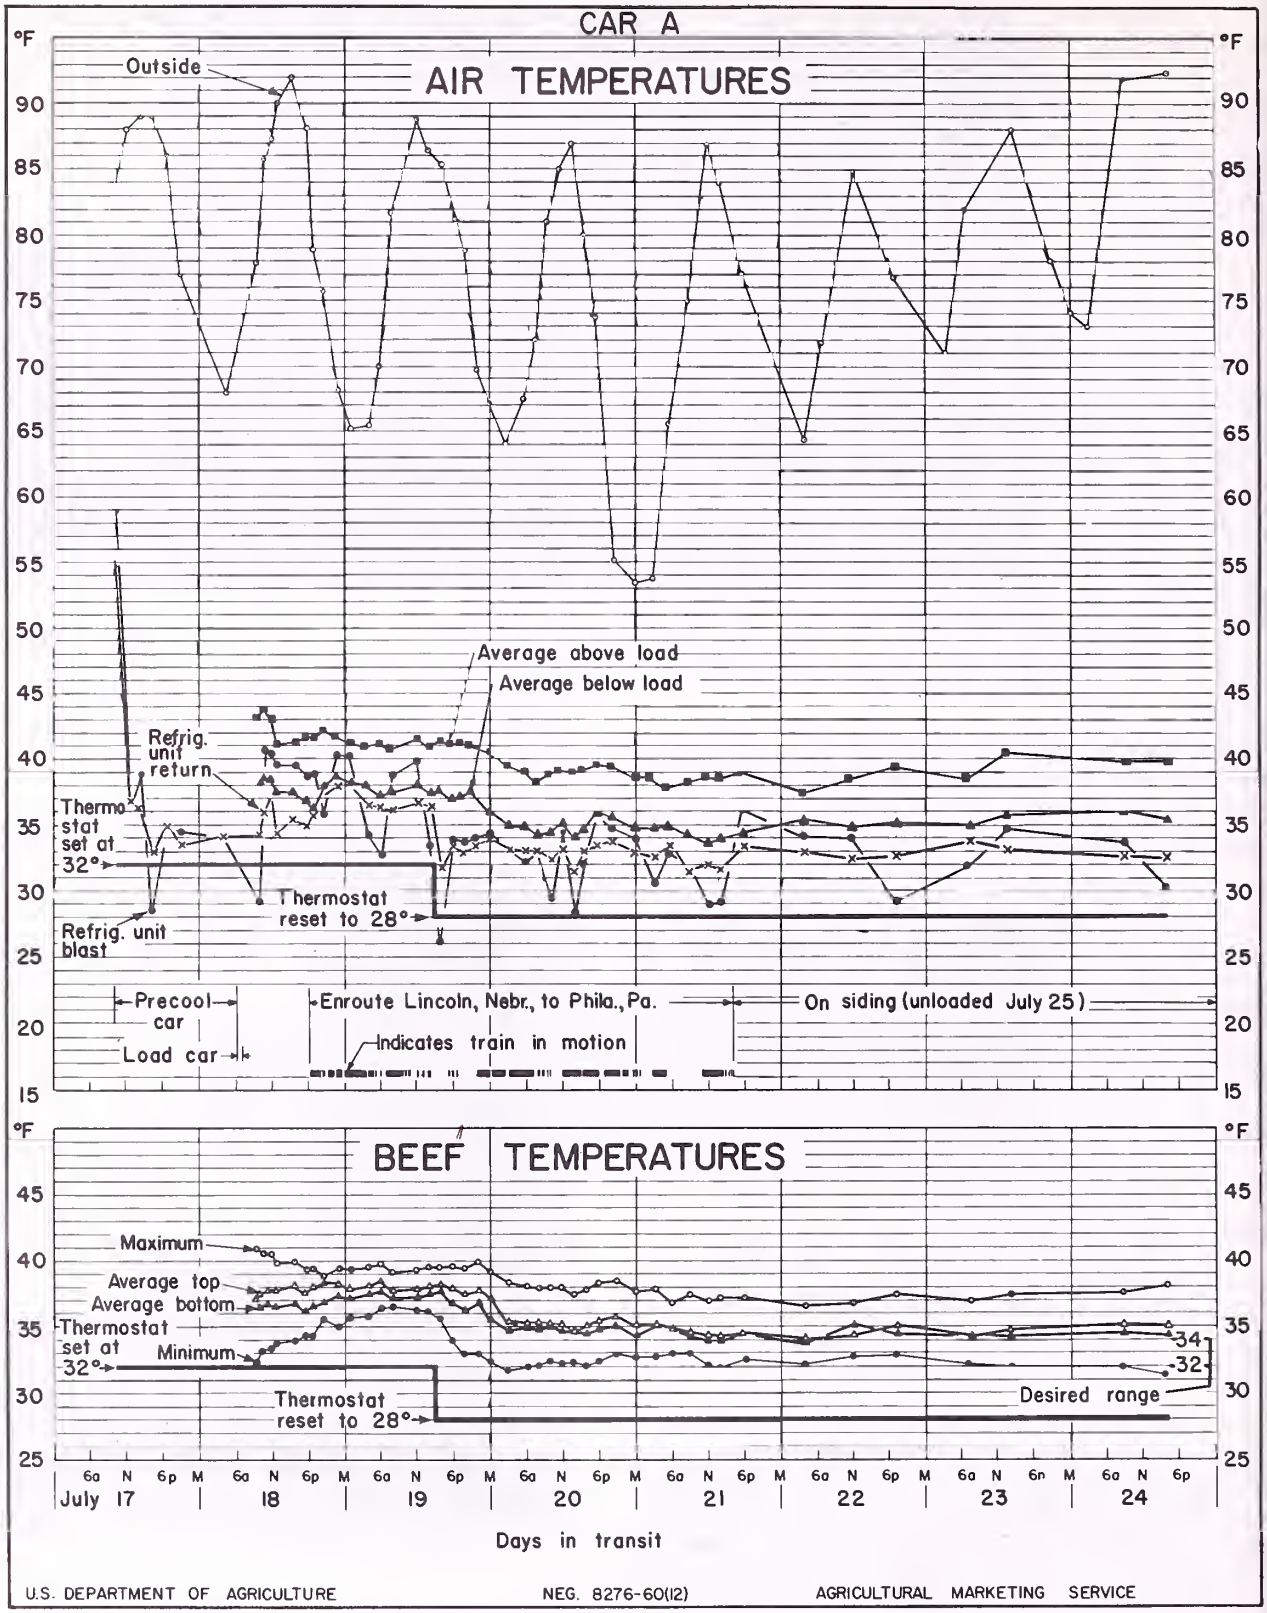
Figure 13.--Temperatures in car A which blasted air directly into load.

Car A.--The thermostat was originally set at 32° F. On the second day, thermocouple readings showed that the beef was not cooling as expected. The thermostat was reset to 28° at 3:30 p.m. on July 19. After the fifth day, on July 24, the following approximate temperatures were noted:

Air, average above load.....40°
Air, average below load.....36°
Air, refrigeration unit blast.....34°
Air, refrigeration unit return.....33°
Beef, average top.....35°
Beef, average bottom.....34°

The refrigeration unit return (33°) was 5° higher than the thermostat setting; the beef (34°) was 6° higher than the thermostat setting. Thus, it would seem that the thermostat was not functioning properly or that the sensing bulb was located in the wrong place to give a true picture of inside commodity temperatures.

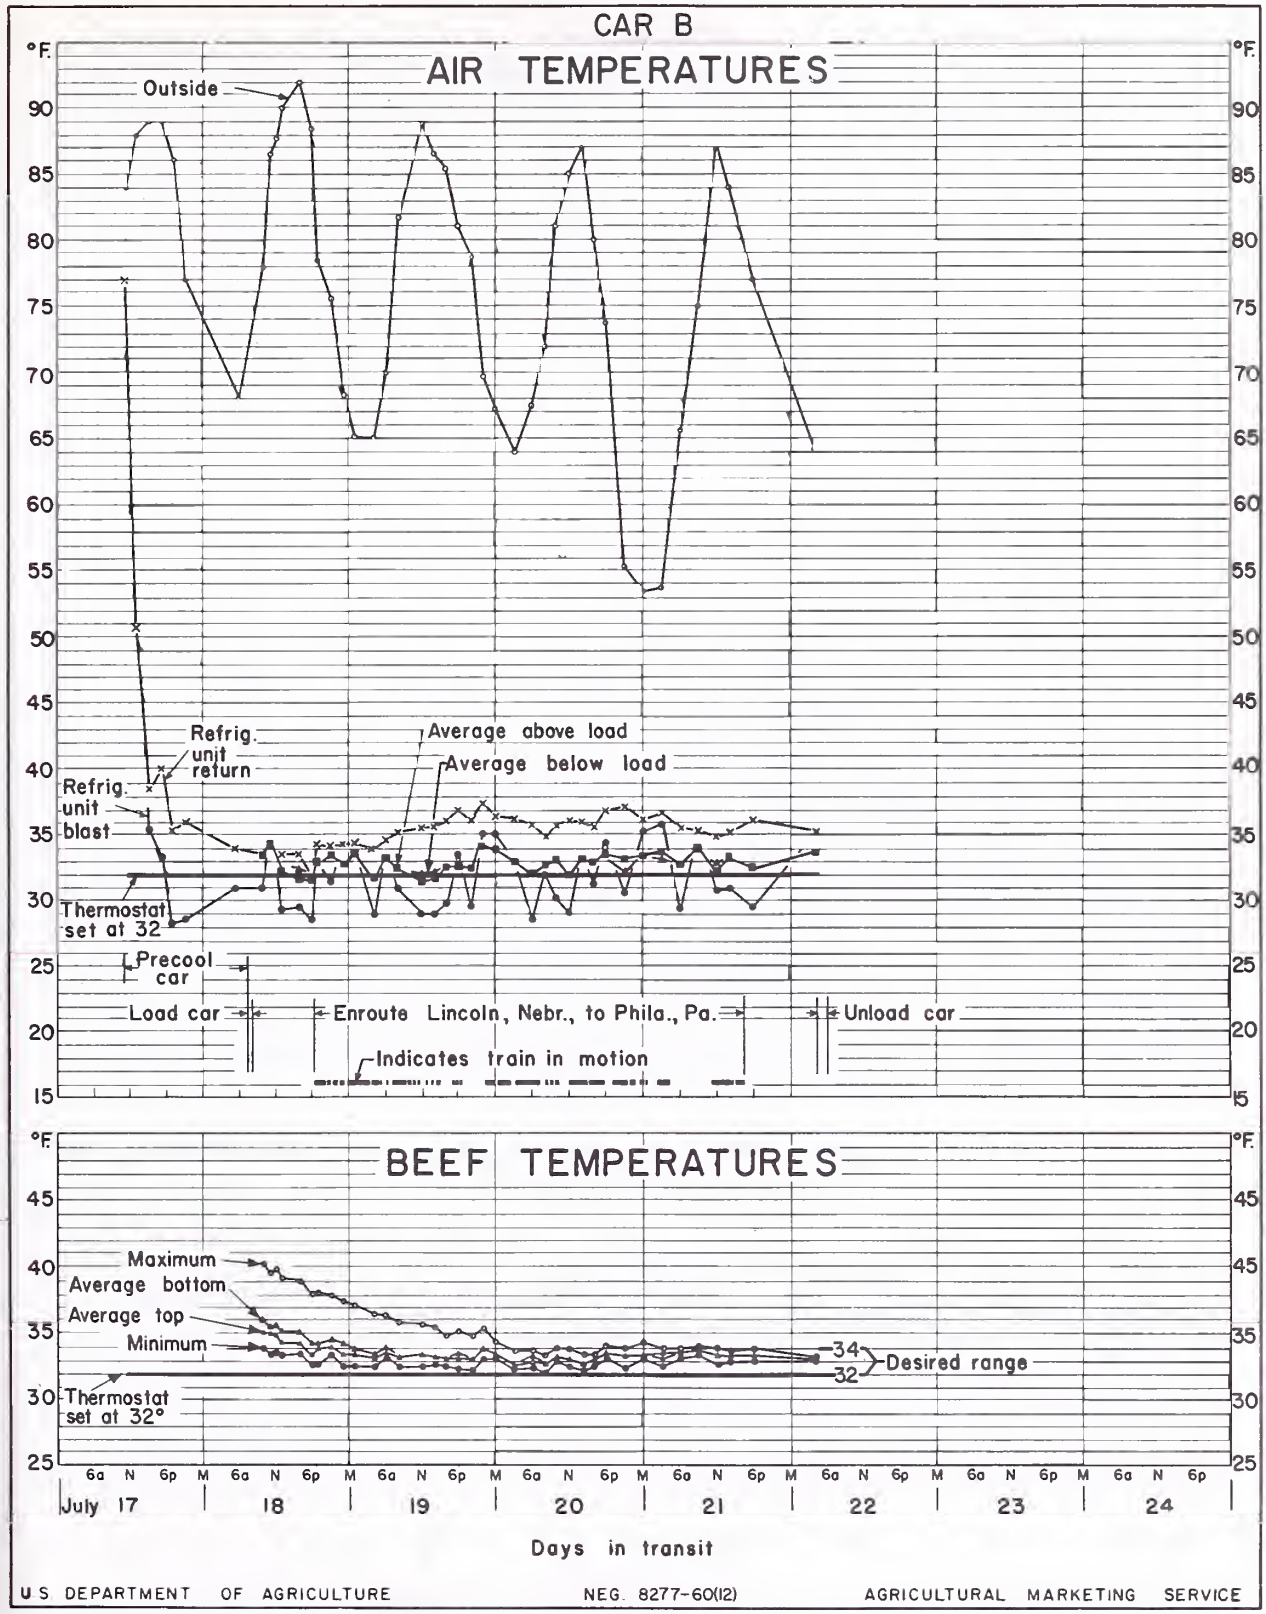
Figure 14.--Temperatures in car B with envelope type of air distribution.

Car B.--The thermostat was set at 32° F., and the beef was delivered at approximately 33°. This was a very good performance.

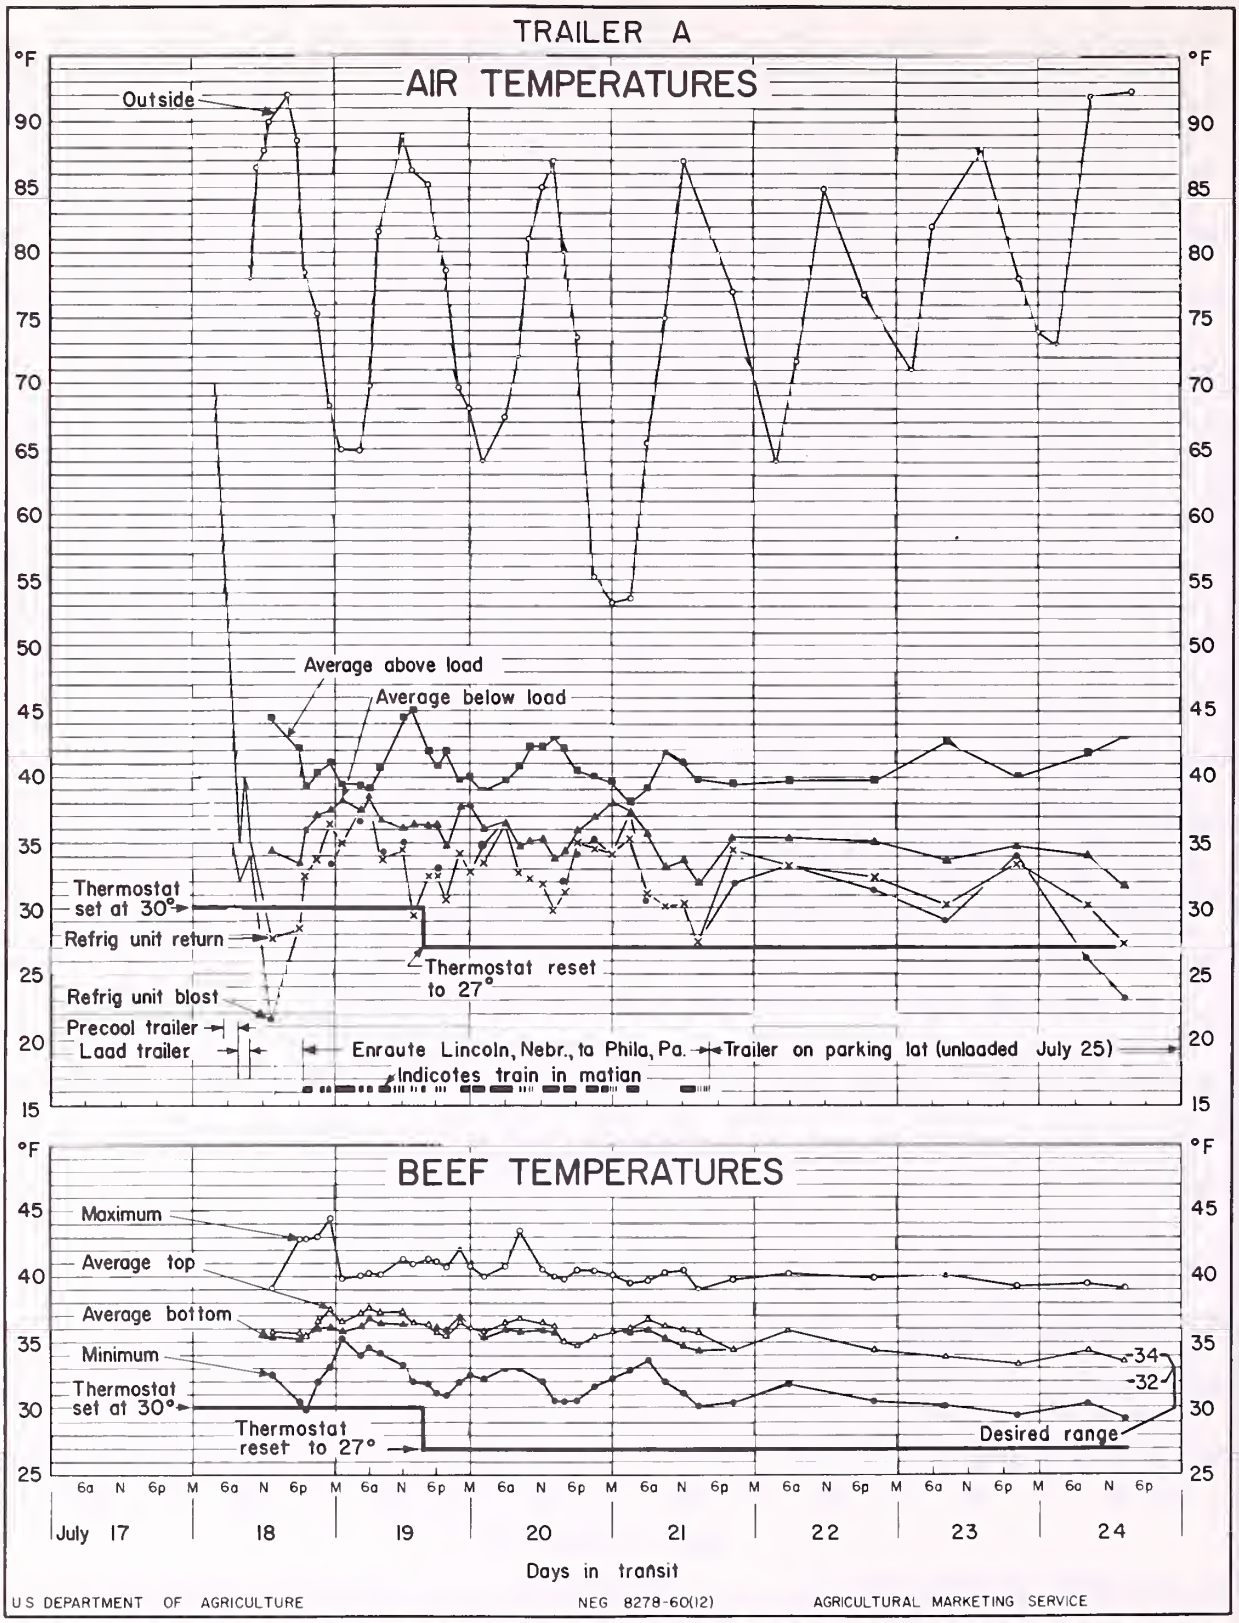
Figure 15.--Temperatures in trailer A which blasted air directly into load.

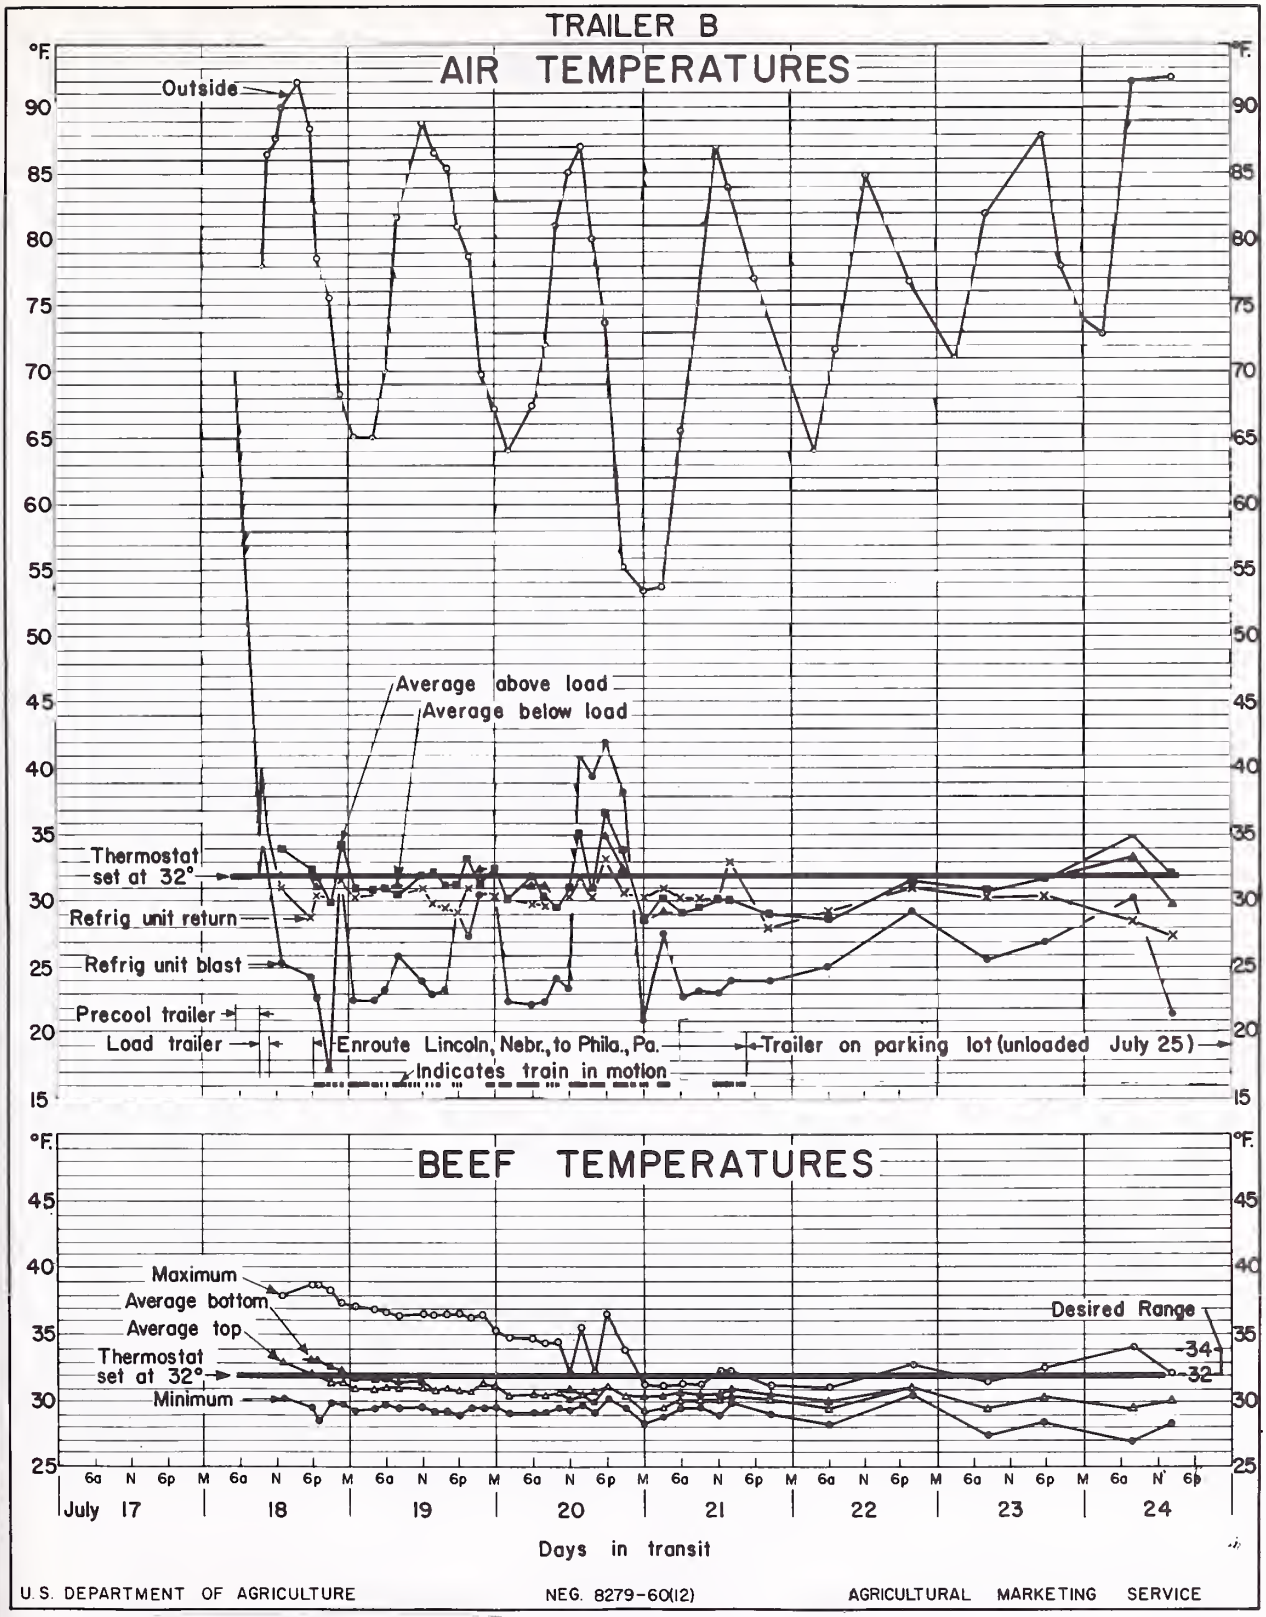
Figure 16.--Temperatures in trailer B which blasted air directly into load.

Trailer B.--The thermostat was set at 32° F. At the end of the trip, the refrigerating unit return was approximately 27° and the average beef temperature was about 30°. Thus, actual temperatures were from 2° to 5° below the thermostat setting. Among the trailers, this one held the closest range of minimum and maximum beef temperatures.

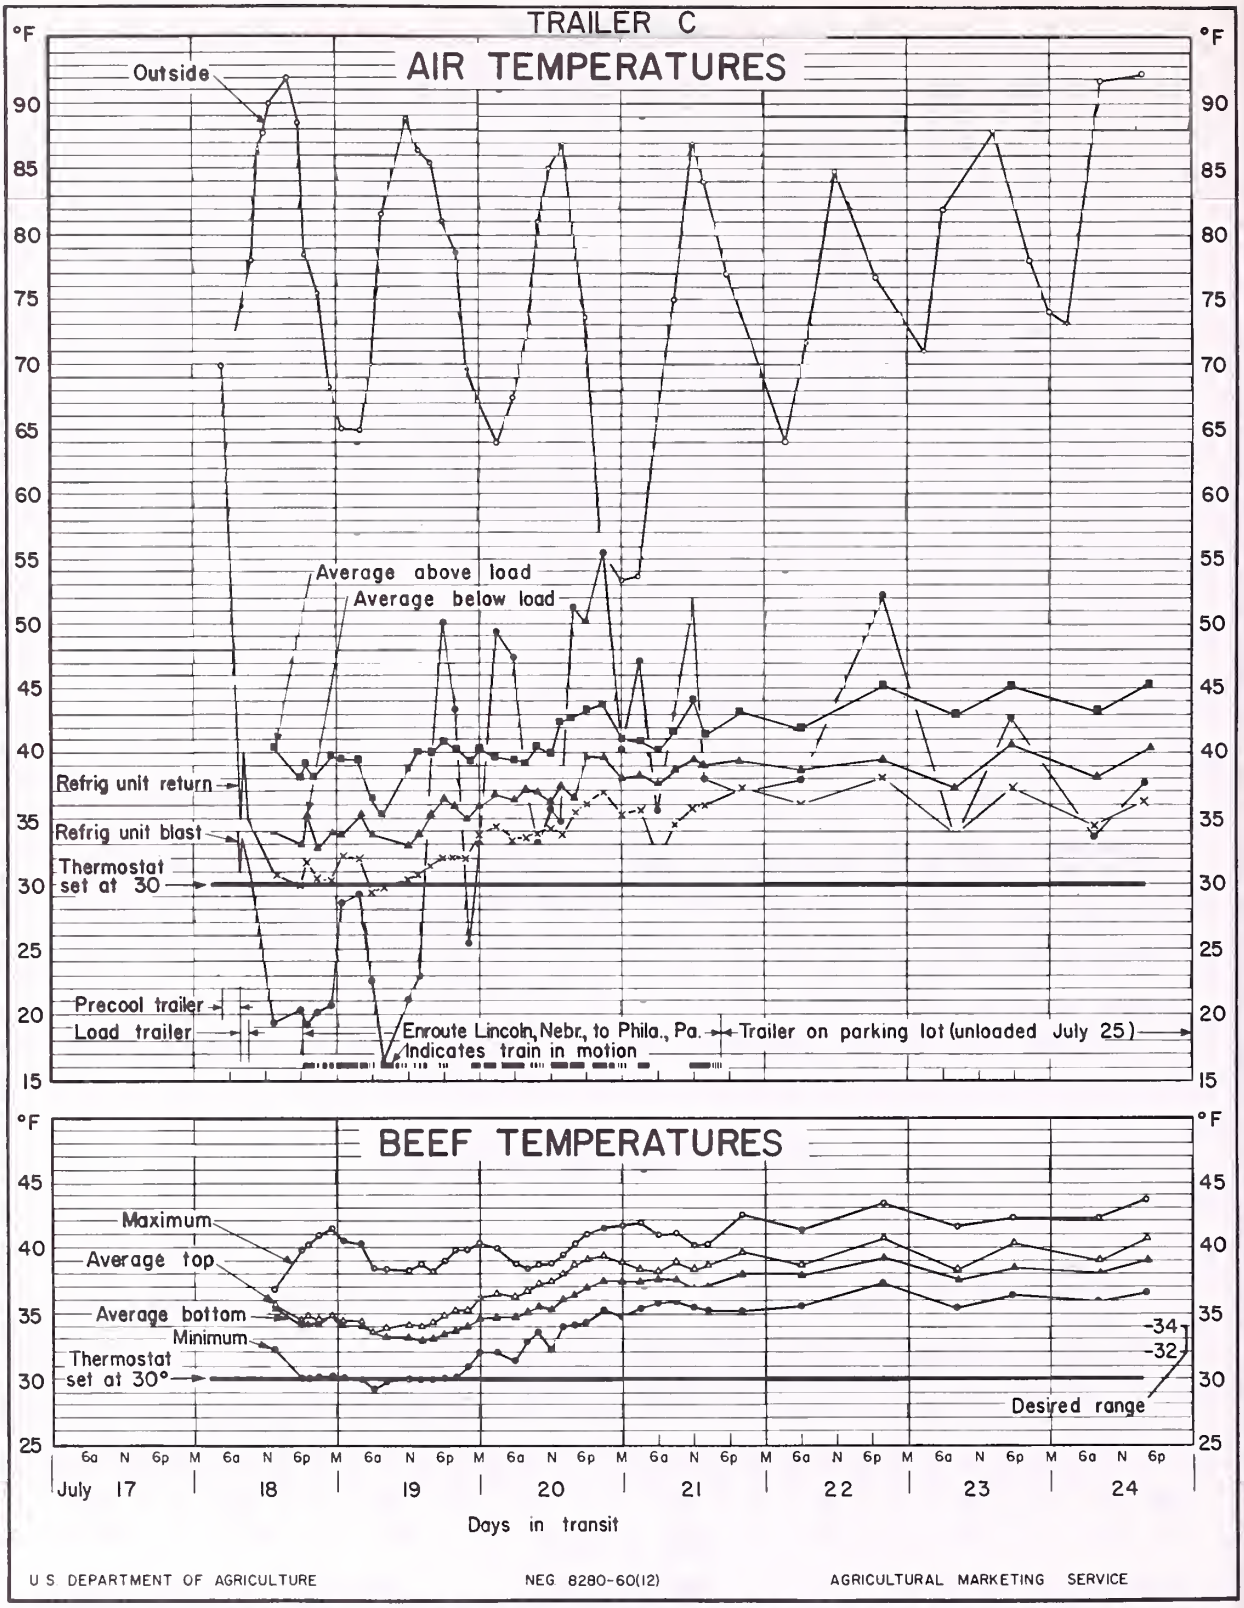
Figure 17.--Temperatures in trailer C which blasted air directly into load.

Trailer C.-- Here, as with trailer A, the thermostat was set at 30° F. instead of 32° at the start of the trip. Figure 17 shows a gradual rise in inside air and beef temperatures during the trip. The average beef temperature at destination was approximatley 40°. It is probable that there was some malfunction in the refrigerating unit which prevented it from operating at full capacity.

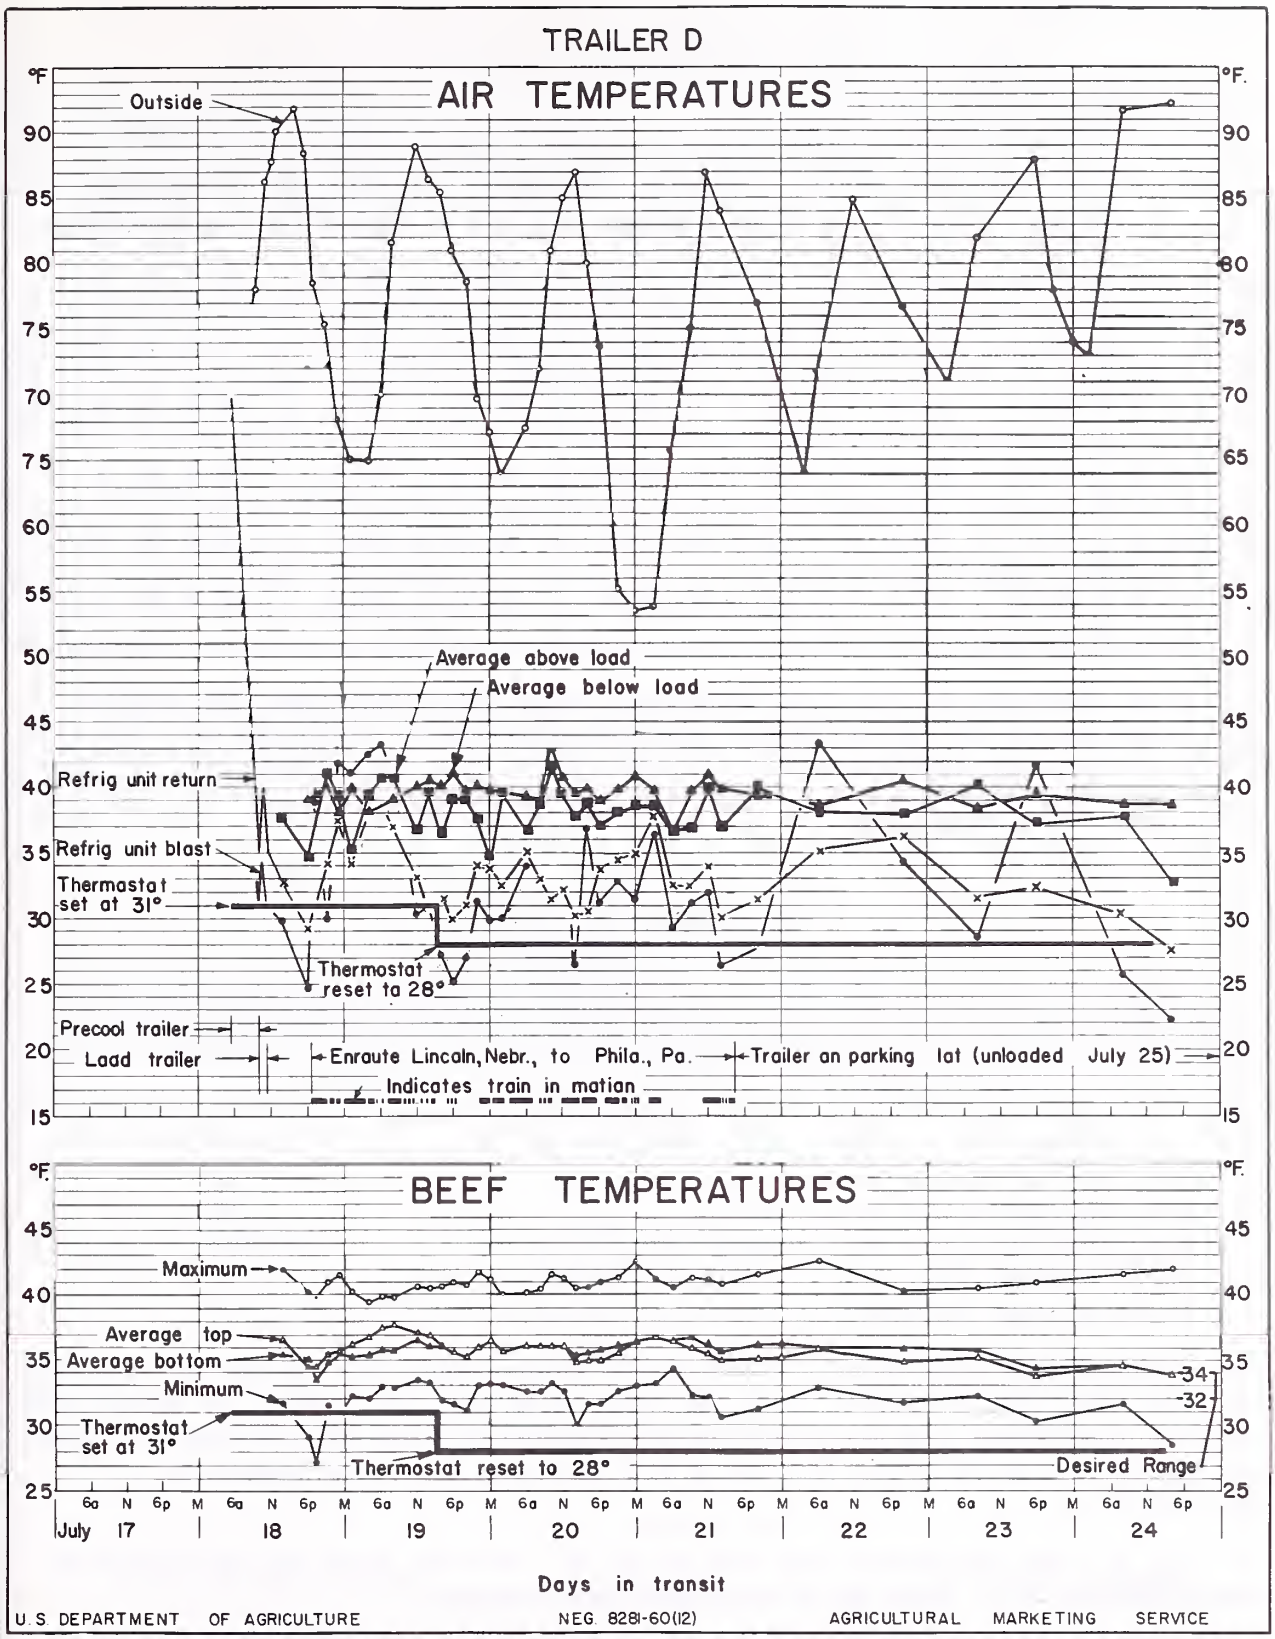
Figure 18.--Temperatures in trailer D which blasted air directly into load.

Trailer D.--The thermostat was originally set at 31° F. instead of 32°, as intended. It was reset to 28° on the second day. At the end of the trip the refrigerating unit return temperature was 28°. The average beef temperature was 34°, or 6° higher than shown by the thermostat setting.
